The US Navy's Helicopter Integrated Diagnostics System (HIDS) Program: Power Drive Train Crack Detection Diagnostics and Prognostics, Life Usage Monitoring, and Damage Tolerance; Techniques, Methodologies, and Experiences

Andrew Hess William Hardman

US Naval Air Warfare Center Aircraft Division Patuxent River, Md 20670-1534 United States Harrison Chin John Gill BFGoodrich Aerospace 54 Middlesex Turnpike Bedford, MA 01730 United States

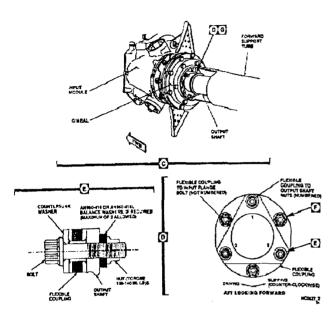
HIDS system also detected a fleet removed input module suspected of being an every-other-tooth gearmesh candidate. These gearboxes were emanating a strong tone at one-half the normal gearmesh frequency, and it was believed this tone was contributing to premature removals of the mating T700 engines due to torque reference shaft wear. Figure 10 exhibits a gear health indicator (algorithm) of such a component tested at Trenton which shows baseline and fault (run numbers 149 through 170) data.

Fig. 7. High Speed Shaft Interface.
